## **WASTE MANAGEMENT PLAN**

## **Alexan – Fashion Valley Project**

San Diego, California Project No. 474586

April 2016

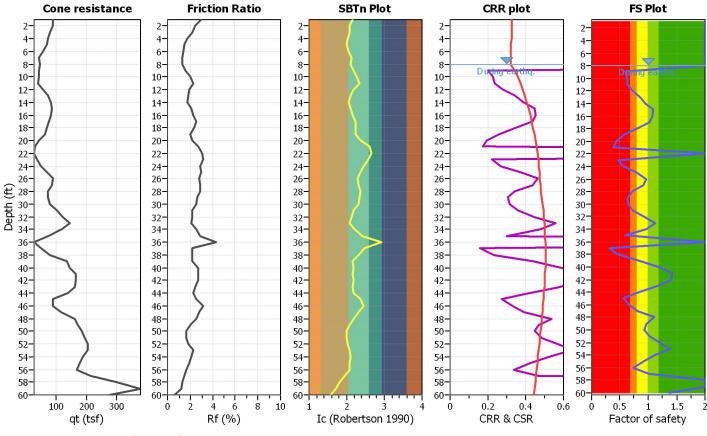
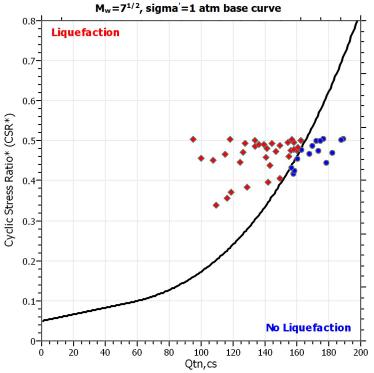
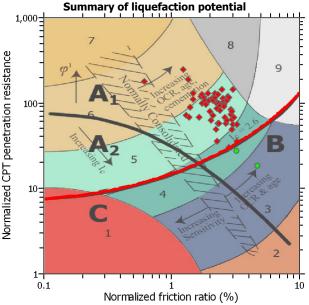
This software is licensed to: Leighton CPT name: CPT-5

Zone  $A_1$ : Cyclic liquefaction likely depending on size and duration of cyclic loading Zone  $A_2$ : Cyclic liquefaction and strength loss likely depending on loading and ground

Zone B: Liquefaction and post-earthquake strength loss unlikely, check cyclic softening Zone C: Cyclic liquefaction and strength loss possible depending on soil plasticity, brittleness/sensitivity, strain to peak undrained strength and ground geometry

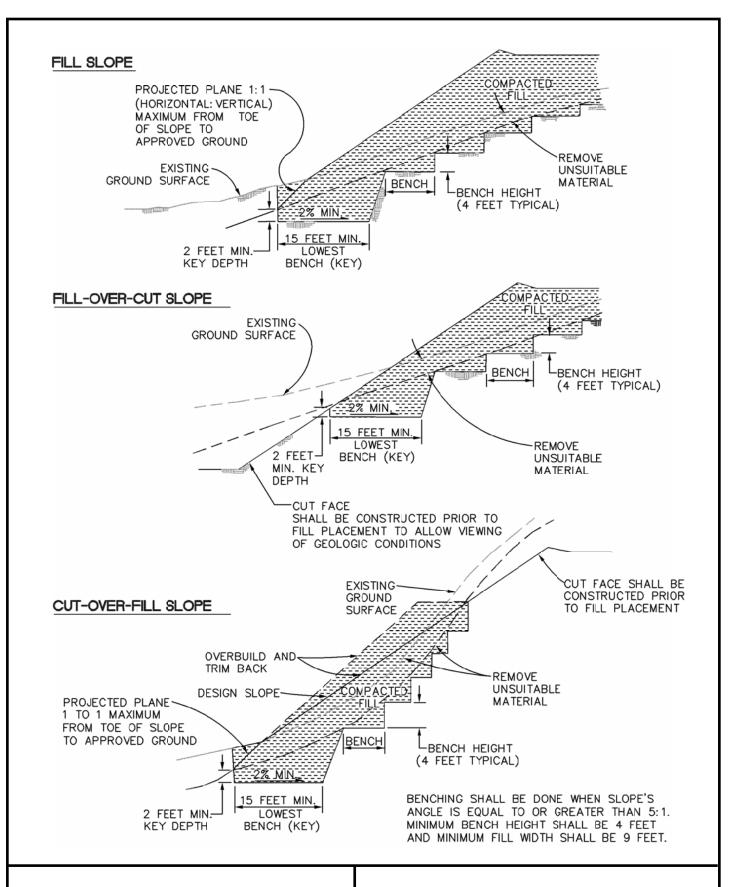
GENERAL EARTHWORK AND GRADING SPECIFICATIONS STANDARD DETAIL A

**KEYING AND BENCHING**

Where fills are to be placed on ground with slopes steeper than 5:1 (horizontal to vertical units), the ground shall be stepped or benched. Please see the Standard Details for a graphic illustration. The lowest bench or key shall be a minimum of 15 feet wide and at least 2 feet deep, into competent material as evaluated by the Geotechnical Consultant. Other benches shall be excavated a minimum height of 4 feet into competent material or as otherwise recommended by the Geotechnical

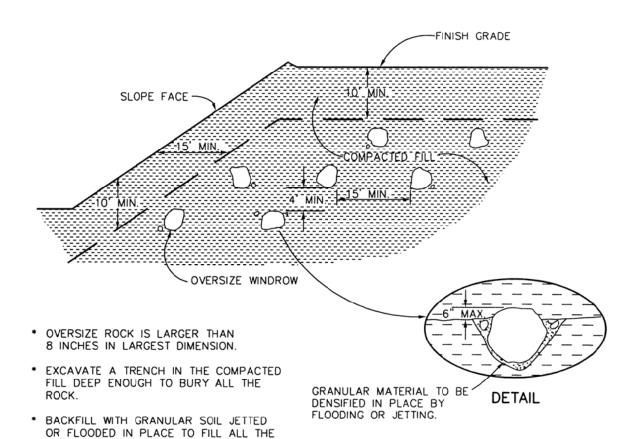
GENERAL EARTHWORK AND GRADING SPECIFICATIONS STANDARD DETAIL B

\* WINDROW OF BURIED ROCK SHALL BE PARALLEL TO THE FINISHED SLOPE.

\* DO NOT BURY ROCK WITHIN 10 FEET OF

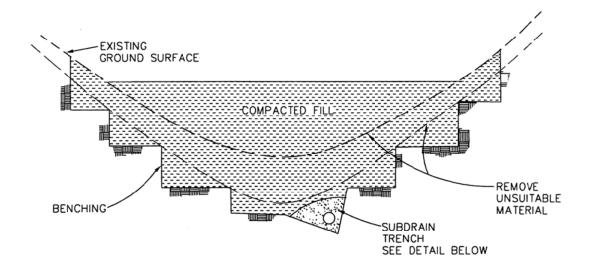
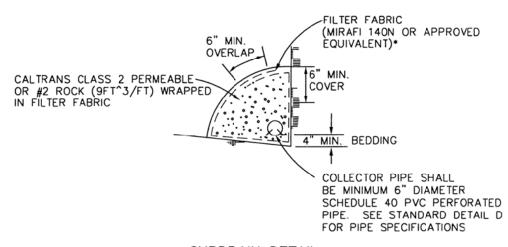
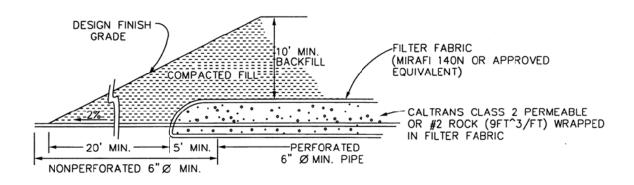
GENERAL EARTHWORK AND GRADING SPECIFICATIONS STANDARD DETAIL C

# SUBDRAIN DETAIL

# DETAIL OF CANYON SUBDRAIN OUTLET

**CANYON SUBDRAINS**

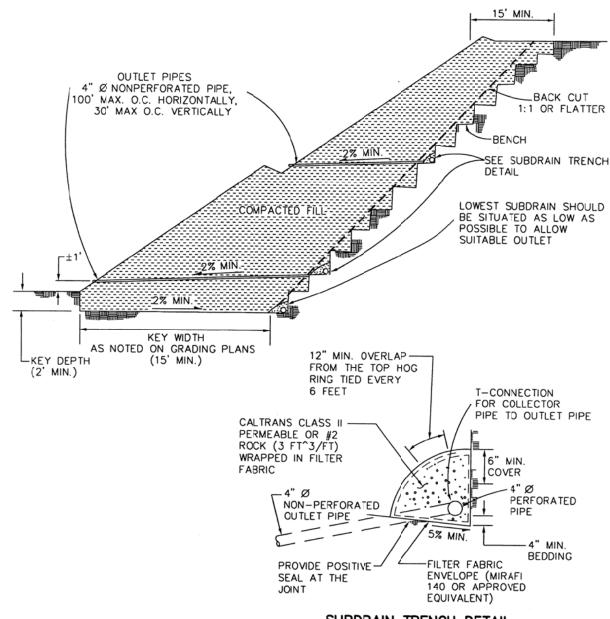
BUTTRESS OR REPLACEMENT FILL SUBDRAINS

# SUBDRAIN TRENCH DETAIL

SUBDRAIN INSTALLATION — subdrain collector pipe shall be installed with perforation down or, unless otherwise designated by the geotechnical consultant. Outlet pipes shall be non-perforated pipe. The subdrain pipe shall have at least 8 perforations uniformly spaced per foot. Perforation shall be 1/4" to 1/2" if drill holes are used. All subdrain pipes shall have a gradient of at least 2% towards the outlet.

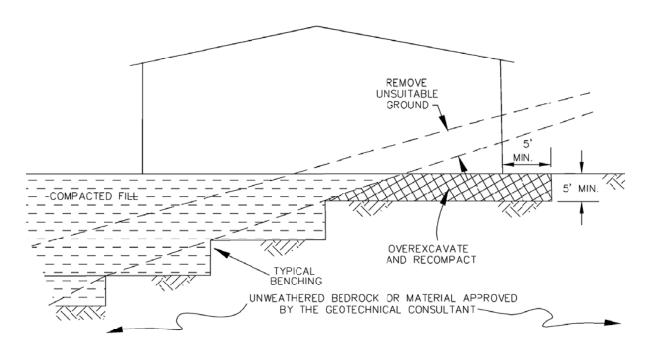
GENERAL EARTHWORK AND GRADING SPECIFICATIONS STANDARD DETAIL E

# CUT-FILL TRANSITION LOT OVEREXCAVATION

TRANSITION LOT FILLS

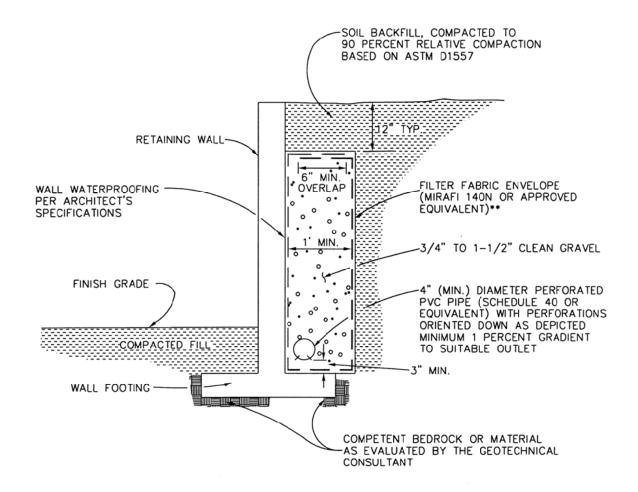
GENERAL EARTHWORK AND GRADING SPECIFICATIONS STANDARD DETAIL F

NOTE: UPON REVIEW BY THE GEOTECHNICAL CONSULTANT, COMPOSITE DRAINAGE PRODUCTS SUCH AS MIRADRAIN OR J-DRAIN MAY BE USED AS AN ALTERNATIVE TO GRAVEL OR CLASS 2 PERMEABLE MATERIAL. INSTALLATION SHOULD BE PERFORMED IN ACCORDANCE WITH MANUFACTURER'S SPECIFICATIONS.

RETAINING WALL DRAINAGE

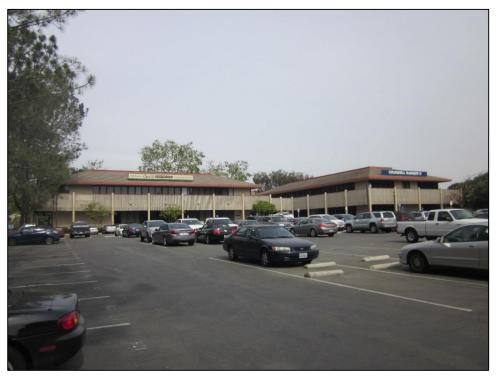
Figure 4. Project site, facing north.

Figure 4. Project site, facing north. Figure 5. Project site, facing southeast. Figure 6. Project site, facing south.

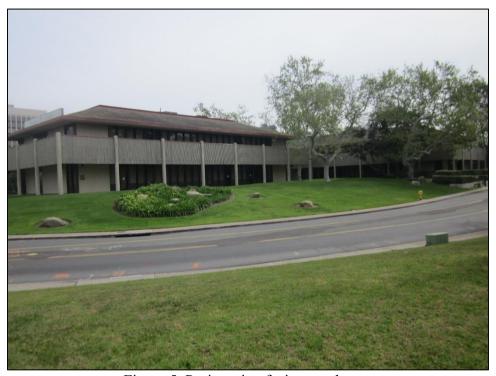
Figure 5. Project site, facing southeast.

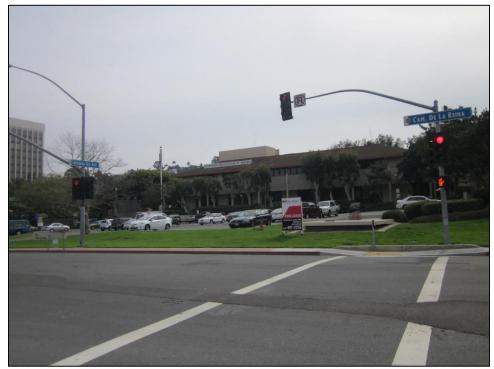
Figure 6. Project site, facing south.

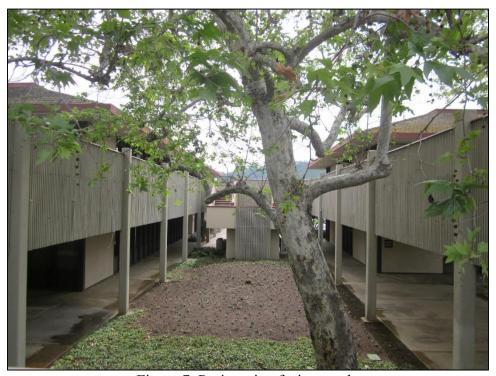
Figure 7. Project site, facing north.

Figure 7. Project site, facing north.
